YOU CAN'T SEE WHAT YOU CAN'T SEE

CASE STUDY: SANDPIPER RUN

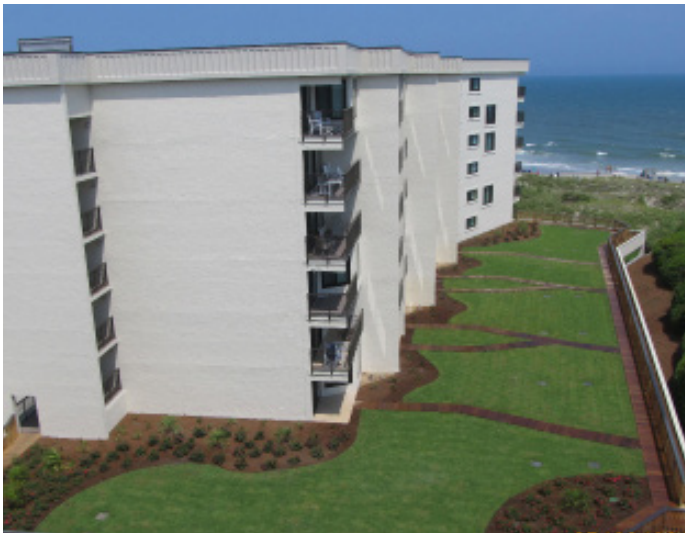
Leaks through roofs and from roof drains were a dilemma for three of the four beach front condominiums in Pawleys Island, SC for the Sandpiper Run Council of Co-Owners, especially when the leaks interrupted use and damaged interior spaces in occupied units. As soon as the leaks were reported (2011 - Building A, 2015 - Buildings C&D), SKA was contacted to investigate. Investigation through the use of infra-red cameras and from exploratory openings revealed the leak sources where water had previously been hidden
