CONCRETE MATERIALS DISTRESS REINFORCING STEEL CORROSION

CASE STUDY: DOCKSIDE CONDOMINIUMS

SKA CASE STUDY

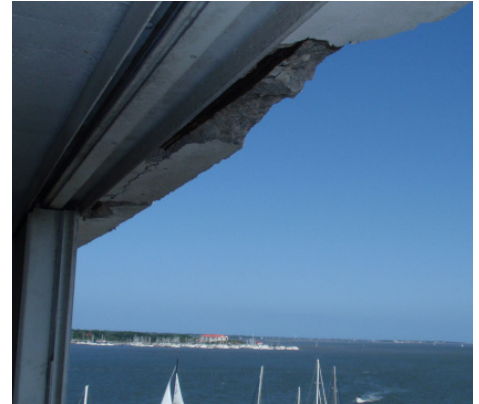
Slab edge distress and overhead spalling hazards prior to repair

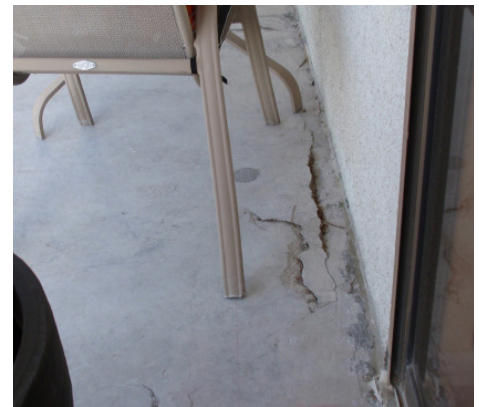
Reinforcing steel corrosion and concrete distress at balconies prior to repair

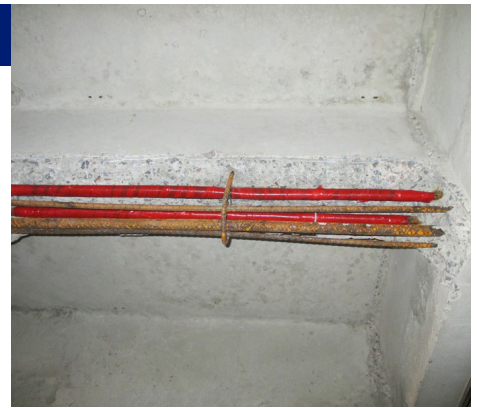
Post-tensioned beam repairs in progress

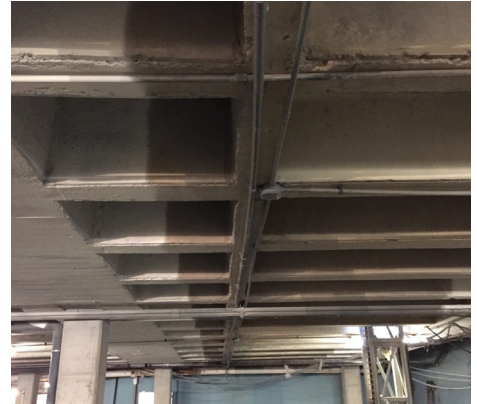
Thermal spray cathodic protection by the System Provider at garage components under the building

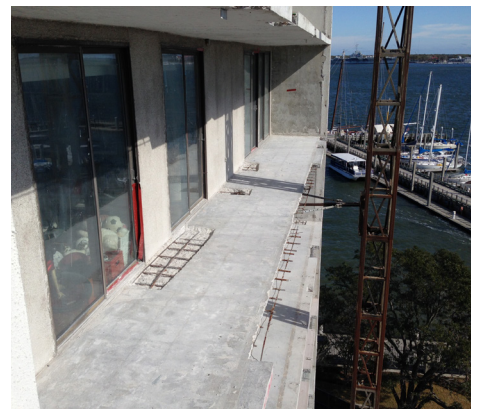
Concrete repairs in progress at balconies

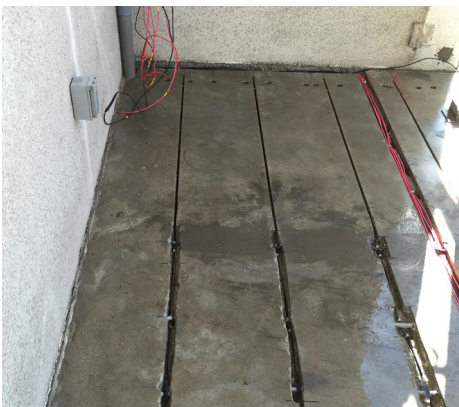
Impressed cathodic protection system installation in progress at balconies

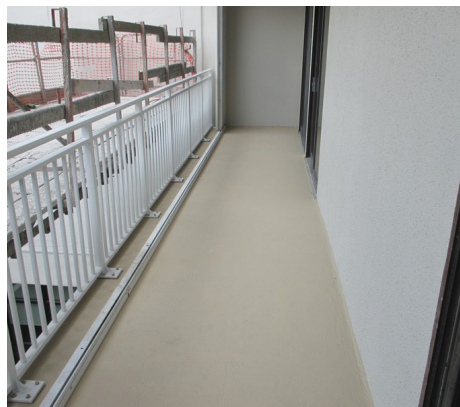
Finished balcony showing new guard rails, completed repairs and new deck coatings

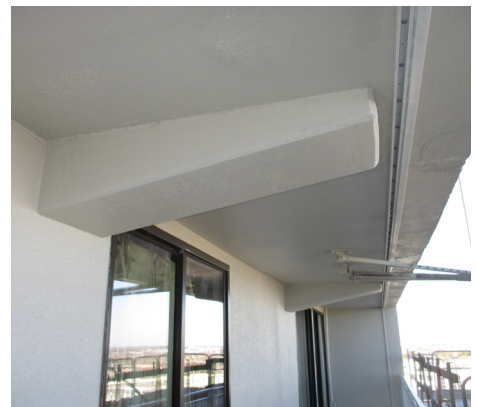
During restoration construction, some hidden or unanticipated conditions were discovered that presented special challenges and required specialized repairs. Longitudinal concrete cracking was discovered near some balcony thresholds due to improper placement of reinforcing steel during original construction that resulted in a significant reduction of flexural capacity. Initially, this condition was corrected by slotting new supplemental reinforcing into the top of the concrete slab. However, due to high costs and the impact on residents during the repairs, this approach was abandoned in favor of installing beam sections on the underside of the balcony decks that could be completed without accessing resident units.

Supplemental beams to address structural deficiencies
