YOU CAN'T SEE WHAT YOU CAN'T SEE

CASE STUDY: SANDPIPER RUN

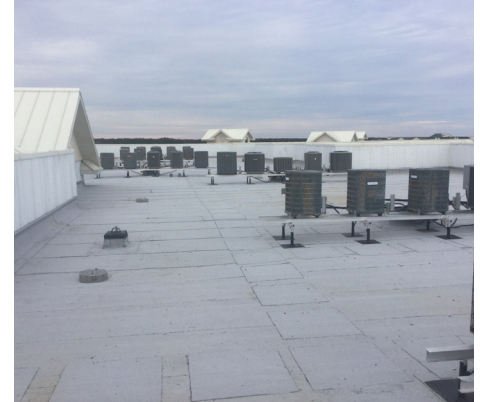
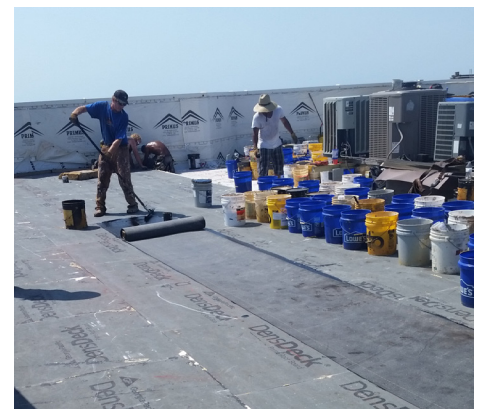
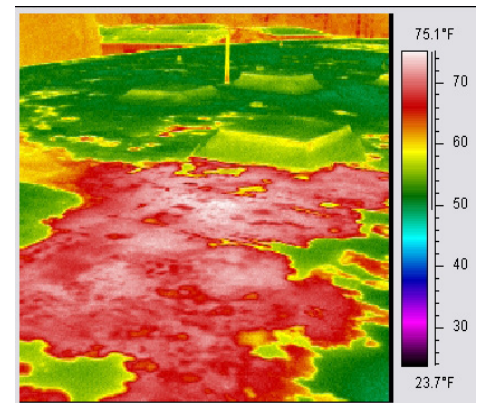
Leaks through roofs and from roof drains were a dilemma for three of the four beach front condominiums in Pawleys Island, SC for the Sandpiper Run Council of Co-Owners, especially when the leaks interrupted use and damaged interior spaces in occupied units. As soon as the leaks were reported (2011 - Building A, 2015 - Buildings C&D), SKA was contacted to investigate. Investigation through the use of infra-red cameras and from exploratory openings revealed the leak sources where water had previously been hidden

Repairs in 2011 were on the existing green roof over the parking structure. Concrete repairs to restore the existing topping slab and structural supports that had corroded from water damage were

completed first before the new roof system was installed. The new roof system selected by the Owners included new thermoplastic membrane, flashings and protection course for a green roof system that was designed to support intensive shallow vegetation. Drainage was improved through the use of new roof drains and storm drain piping. Future leak detection was captured by imbedding an electronic field vector mapping system under the roof system.

To limit interior renovation costs and interruption to occupants, the repairs in 2015 included closing of the primary roof drains and using the secondary drains as the primary drainage with overflow scuppers through the parapet as the secondary back-up. This unique solution saved the owners time and money, and provided a new roof system with better drainage from the original through the redesign of the tapered insulation. Coordination and planning to complete the re-routing of the piping was key to the success of the roof installation. The new roof system was a 20 year warranty SBS modified bitumen roofing system.
