CONCRETE MATERIALS DISTRESS REINFORCING STEEL CORROSION

CASE STUDY: DOCKSIDE CONDOMINIUMS

SKA CASE STUDY

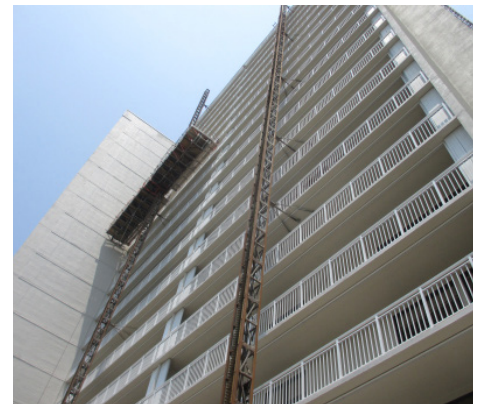
Mast climbers used to access balconies for repairs

contractors used mast-climbers to access balconies in a phased approach to minimize impact to the owners. Concrete repairs were conducted first, followed by installation of the ICCP system, a polymer-modified cement-based protective deck coating, new handrails, and finish coating systems to the balcony walls and soffits. Extensive coordination was required between the two design firms and two concurrently working contractors. Special considerations were required for replaced handrails and re-used shutters, coatings and concrete repair materials to ensure compatibility with the ICCP system, and for addressing identified hazardous materials. Repairs were conducted on post-tensioned concrete in the parking garage prior to installation of thermal spray GCP.
